## Moisture Away®

## Description

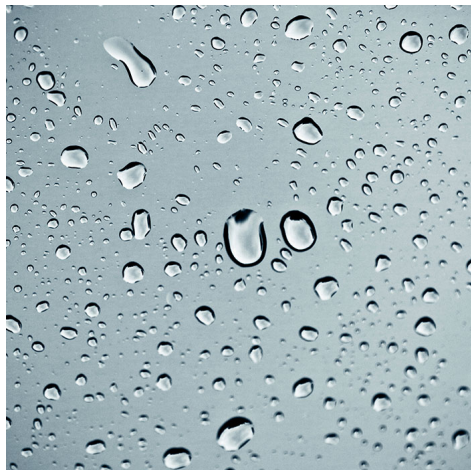
Moisture Away® is a perforated wallcovering that helps prevent and control mildew by allowing moisture trapped in walls to dissipate through evaporation. It is recommended for use in locations where you have water problems beyond the normal moisture associated with humid climates.

Moisture Away® Backing Moisture Away® can be manufactured with the NaMil-Trac® synthetic backing or with U.S. Vinyl's regular cotton backing.

In 1988 U.S. Vinyl Manufacturing Corporation developed our Moisture Away® process which allows our wallcoverings to breathe. Moisture Away is a micro-venting process that allows moisture trapped in substrate walls to evaporate through the vinyl, allowing the substrate walls to remain dry.
